# Studies of Carbon-Surfaced Polymeric, Metallic, and Ceramic Biomaterials

7. Author(s) A. D. Haubold and H. S. Shim			8. Performing Organization Rept. No. GA-A14975	
9. Performing Organization Name and Address General Atomic Company Medical Products Division P. O. Box 81608 San Diego, California 92138			10. Project/Task/Work Unit No.  11. Contract/Grant No. NO1-HV-4-2928

12. Sponsoring Organization Name and Address Devices and Technology Branch, Biomaterials Program Division of Heart and Vascular Diseases National Heart, Lung, and Blood Institute Bethesda, Maryland 20014			13. Type of Report & Period Covered Annual 4/1/77 - 3/31/78  14.

GA-A14975

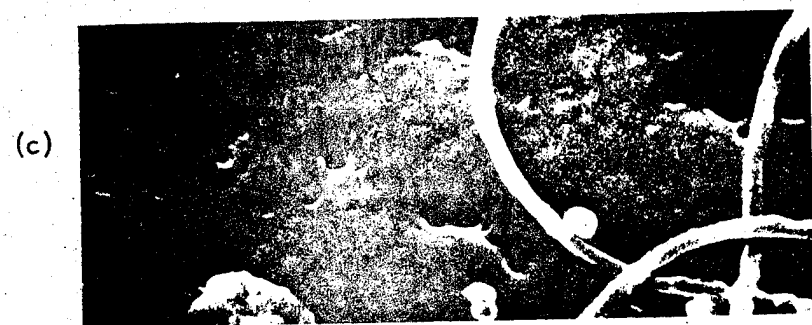
Dr. R. Kahn recently reported on pseudointimas produced by seeding various fabrics with WI-38 cells. He found that carbon-coated nylon consistently was the best pseudointimal substrate among the materials tested. However, using transmission electron microscopy, he found the carbon coating to be brittle and subject to phagocytosis. The particular carbon-coated specimens Dr. Kahn used were fabricated several years ago. The carbon coating was anisotropic and consequently expected to be brittle. Carbon coatings currently being produced are isotropic and expected to be less brittle. We have received new disk samples of polyester (polytetramethylene terephthalate) with an impermeable estane backing from Dr. Kahn for coating. Ten disks have been coated and are ready for shipment to Dr. Kahn. Examination of one of the coated disks shows the carbon coating to be uniform and crack-free. Typical SEM photomicrographs are shown in Fig. 2-1.

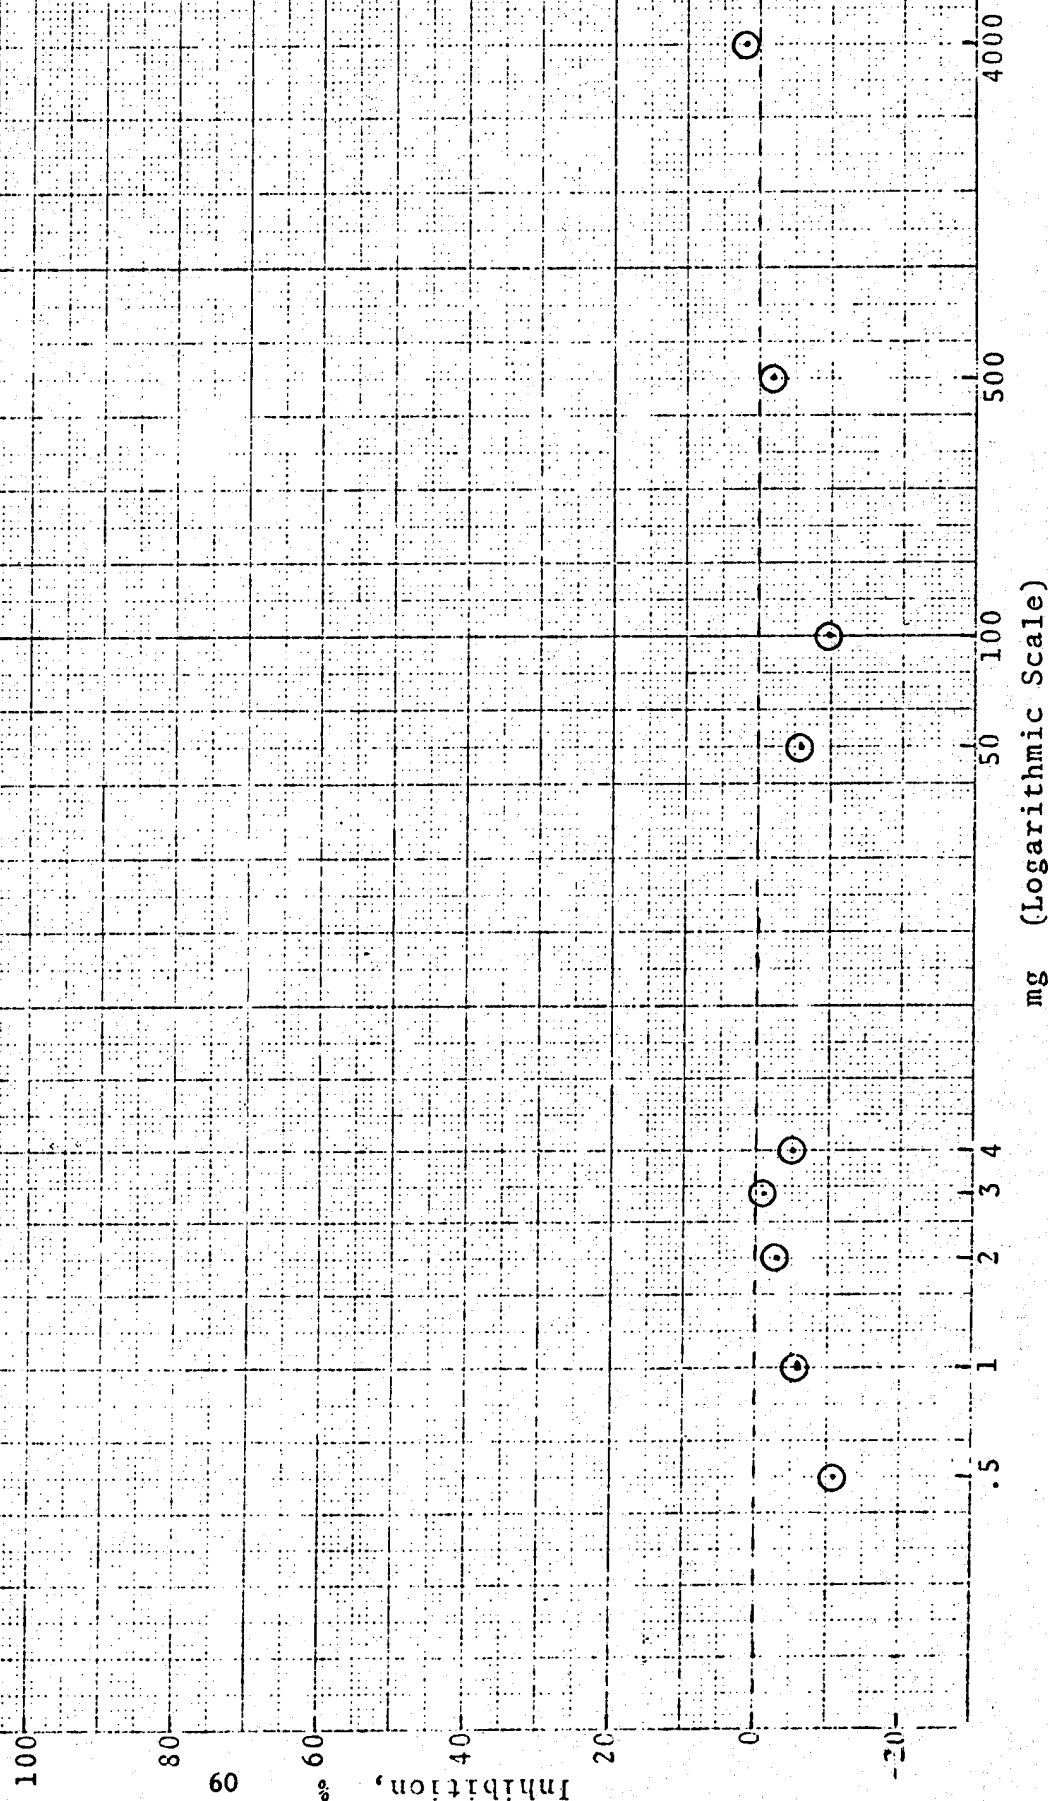
FIGURE 1 : Y-5619 Pelethane Sample 2363-55D

1. Procedure. Various weights of sample per 20 ml. of distilled water were extracted in an autoclave at 121° C for one hour, and then the extracts were included in the cell growth inhibition test.
2. Results. These are shown in Figure 1. As may be noted, none of the extracts with the different sample weights exceeded + 10% inhibition. Values less than 29% inhibition are considered as not being significant.

The x-axis indicated the quantity of material extracted at 121°C, 1 hour, in distilled water. The assay is based on relative growth at 72 hours in the presence and absence of the extract, distilled water control.
